NOTICE OF VIOLATION

Re: Puget Sound Naval Shipyard and Intermediate Maintenance Facility
NPDES Compliance Inspection and Federal Facility Compliance Agreement
NPDES Permit Number WA0002062

NPDES Inspection Report

September 26, 2018

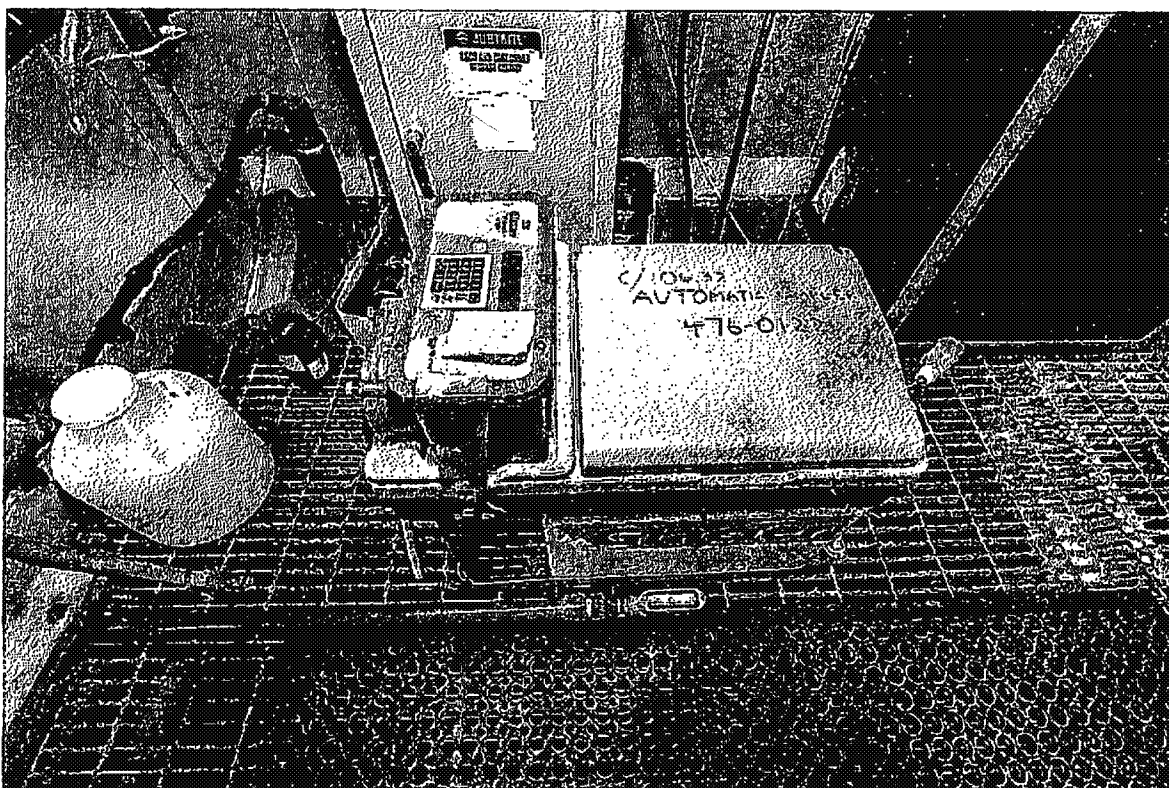
I visited the steam plant and inspected the sampling points for Outfall 021, consisting of a composite sampler (Photo 1) and grab sampling port (Photo 2). Mr. Richardson said that the facility plans to decommission Outfall 021 in 2019 after a planned facility upgrade that will direct all steam plant wastewater to the sanitary sewer system.

Photo 1 / 18-1514-RELEASED-TVN-001 – Composite sampler at Outfall 021 at the Steam Plant

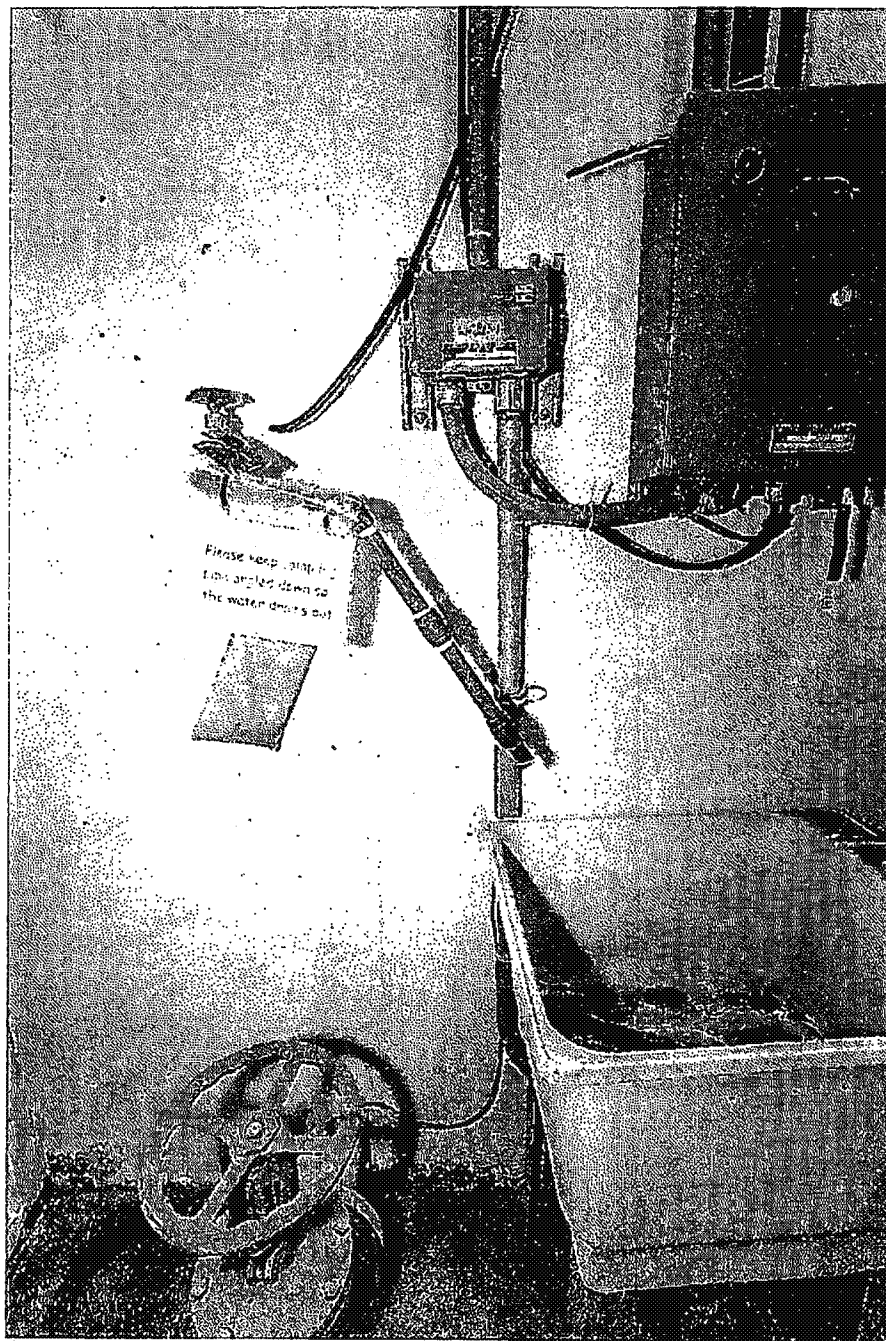
Photo 2 / 18-1514-RELEASED-TVN-004 – Grab sampling port at Outfall 021 at the Steam Plant

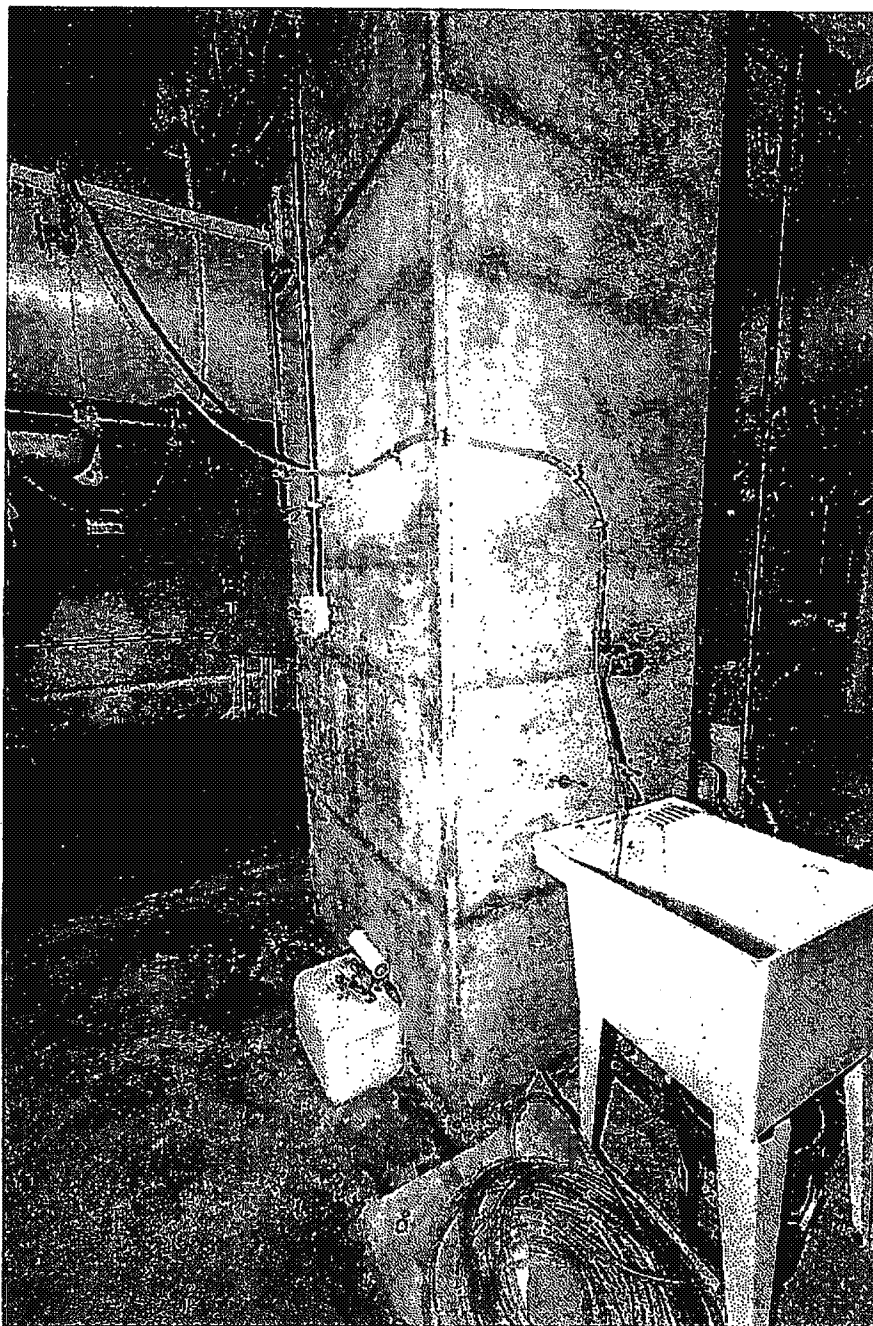
Outfall 019 is located at Drydock 6, which is the facility's largest drydock. I inspected the sampling point at Outfall 019, which consists of a normally open valve connected to a long plastic tube (Photo 3) that drains to a utility sink. Mr. Richardson said that the facility replaces the tube approximately once per month.

I noted that the facility uses a long plastic tube (Photo 3) to collect grab samples for oil and grease at Outfall 019. Although I have not found this technique specifically discussed in approved sampling methods for oil and grease, I noted that the potential for extractable matter to adhere to the plastic sampling tube, combined with the facility's practice of replacing this tube on a monthly basis, could result in measurements that are biased low and not representative of the monitored discharge.

Photo 3 / 18-1514-RELEASED-TVN-005 – Sampling tube for Outfall 019 at Drydock #6
